PRODUCT REFERENCE MEMO

INSPECTION OF CLEVELAND WHEEL ASSEMBLIES 40-40A AND 40-135 AIRCRAFT EFFECTIVITY: CESSNA MODELS 310, 335, 340, 402, 414, 421

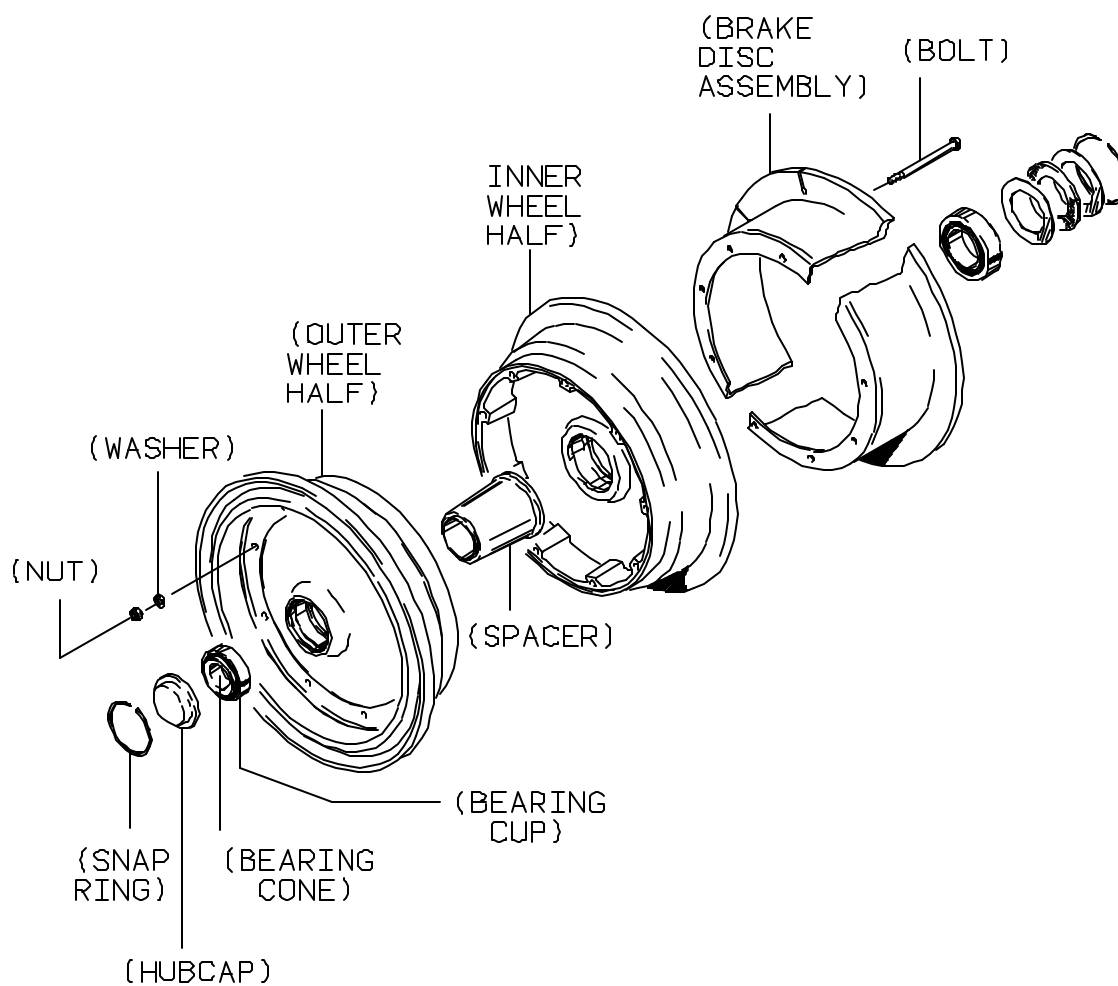
Figure 1
Wheel Inspection

4. Inspect the bearing cup (part number 214-00900) in the outer wheel half assembly for looseness. If the cup is found to be tight, proceed to step "6".

3. Remove the 155-00600 snap ring, 158-00800 hubcap, MS24665-357 cotter pin, MS21258C15 tab washer, CM2910-15 axle nut and 214-01000 bearing cone from the outer (small bore) wheel half assembly. (See Figure 1.)

5. If the cup is found loose, replace the outer wheel half assembly with an assembly of corresponding part number (162-01700) and the spacer between the wheel halves with a new configuration (067-00600) spacer. (See Figure 1.) New configuration spacers are painted white for identification purposes. Proceed to step "7".

6. If the bearing cup (part number 214-00900) in the outer wheel half assembly is found to be secure, no further activity is required at this time; however, at the next tire change or other required wheel disassembly, replace the existing spacer between the wheel halves with a new configuration (067-00600) spacer. New configuration spacers are painted white for identification purposes. Proceed to step "7".

7. Upon completion of inspection and/or component replacement, reinstall the 214-01000 bearing cone, MS21258C15 tab washer and CM2910-15 axle nut. While rotating wheel, tighten axle nut to 40 in-lb. Back off nut to "0" and, while rotating wheel, retighten to 20 in-lb. If slot in nut and hole in axle do not align, continue tightening until first locking position and install new MS24665-357 cotter pin. Reinstall 158-00800 hubcap, 155-00600 snap ring and remove aircraft from jacks.
