PRODUCT REFERENCE MEMO

EXTERNAL CALIPER BRAKE ASSY – PISTON ORIENTATION – INSPECT/CORRECT

EFFECTIVITY: Any external brake assemblies that use a piston that is flat on both sides.

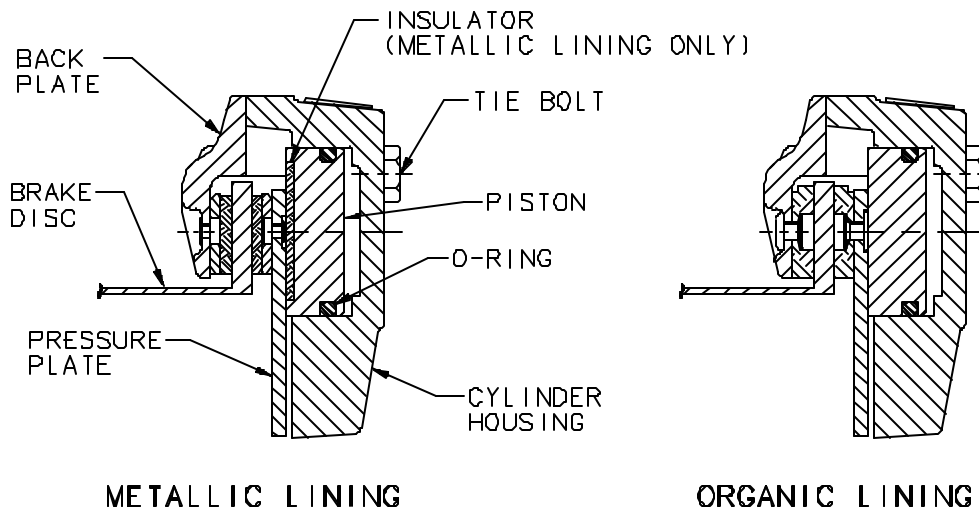
REASON: Informational- Parker Hannifin has received a report of a P/N 30-9 brake assembly with the piston installed backwards. The piston o-ring is located closer to one end of the piston than the other. That end is to be inserted towards the bottom of the cylinder piston bore cavity. Proper installation provides adequate engagement of the o-ring to cylinder bore for minimum lining and disc wear conditions. A brake caliper with an incorrectly installed piston may leak hydraulic fluid from around the piston prior to the linings and discs reaching their minimum thickness replacement limits.

Continued use of any brake caliper with an incorrectly installed piston can result in loss of brake effectiveness or directional control of the aircraft.

FIGURE 1- CROSS-SECTIONAL VIEW SHOWING CORRECT PISTON ORIENTATION FOR BRAKE ASSEMBLIES WITH METALLIC OR ORGANIC LINING

1. With back plate properly installed, inject low air pressure into the brake fluid port to push the piston out to expose 1/8 to 3/16 of an inch. If you don't see the o-ring, then the o-ring groove is correctly positioned on the inner side of the piston and no further action is required.
2. If the o-ring is visible then disassemble, inspect and reinstall piston with proper orientation in accordance with the Figure 1 above and AWBCMM0001 Component Maintenance Manual (available from Web site: www.parker.com/cleveland) prior to installation on the aircraft.

1. Loosen back plate tie bolts 3 to 4 complete turns. Do not remove back plate. Apply slight brake pressure at the pedals as needed to move the piston. The piston will extend and be visible between the cylinder housing and the pressure plate. You may need an assistant to inspect the piston while you are applying brake pressure.

2. If the o-ring is visible after 1/8 to 3/16 of an inch of piston travel then the piston is installed incorrectly. Disassemble, inspect and replace any worn components. After inspection, reassemble and test in accordance with the AWBCMM0001 Component Maintenance Manual. Make appropriate log book maintenance entry.

3. If the o-ring is not visible after 1/8 to 3/16 of an inch of piston travel and no fluid leakage is observed, the piston is installed correctly. Re-torque the tie bolts to value specified for your specific brake assembly in accordance with the AWBCMM0001 Component Maintenance Manual (available from Web site: www.parker.com/cleveland).
