Wheels & Brakes

# SERVICE BULLETIN

## POSSIBLE DEVELOPMENT OF CIRCUMFERENTIAL CRACKS IN CLEVELAND BRAKE DISCS USED ON CERTAIN MODELS OF THE PIPER PA-31 NAVAJO AIRCRAFT

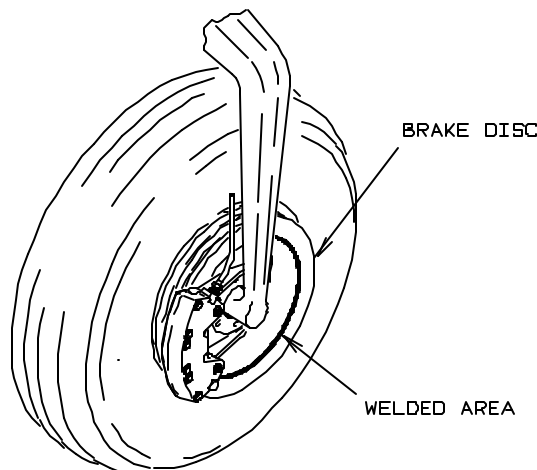
Sketch #1

Visually inspect the welded area (see Sketch #1) for evidence of circumferential cracks. This type of crack will split the paint and is readily visible to the naked eye. If cracks are found, replace with a new brake disc of the corresponding part number.

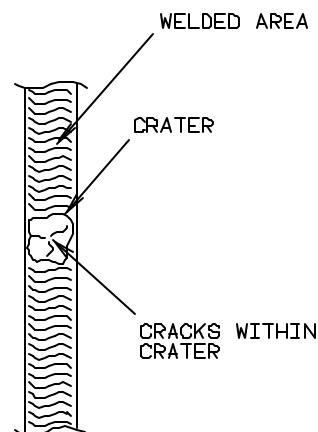
Sketch #2

**NOTE:** A slight impression, or crater, may be found in the weld bead (see Sketch #2). This crater is caused by electrode removal at the end of the welding cycle. Small cracks contained within this crater are not detrimental and does not necessitate brake disc replacement.
