SERVICE BULLETIN

MAIN BRAKE ASSEMBLY 30-204A – TORQUE RING – INSPECT/REPLACE

- EFFECTIVITY:** Parker Hannifin Main Landing Gear Brake Assembly Model Number 30-204A, S/N's 101 thru 872, assembled with Torque Ring P/N 065-15400.
- APPLICABILITY:** Raytheon Aircraft Co. models 1900C and 1900D, equipped with Parker Hannifin, Aircraft Wheel & Brake, Main Wheel and Brake Assembly Conversion Kit P/Ns 199-184, 199-220, or 199-220A (ref. STC SA1789GL).

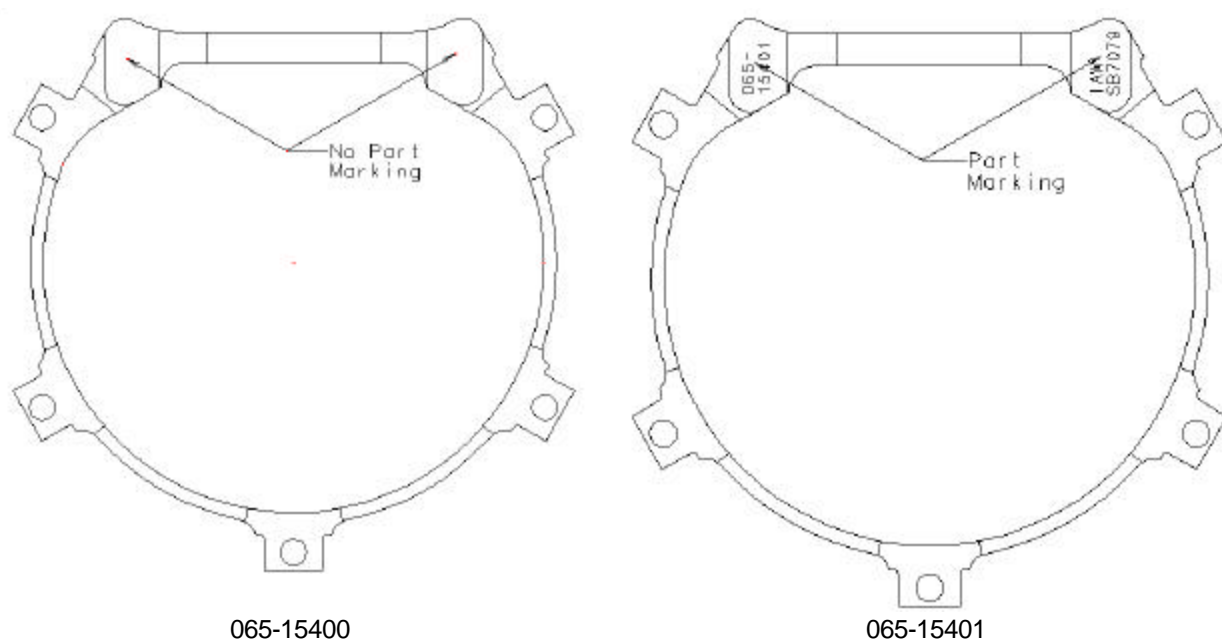
Figure 1

- REASON:** Raytheon Aircraft Co. (RAC) Service Bulletin 32-3576 introduced main landing gear (MLG) socket, RAC P/N 129-810022-0003. RAC P/N 129-810022-0003 interferes with Parker Hannifin P/N 065-15400. P/N 065-15400 is a component of Parker Hannifin Brake Assembly 30-204A that was used on Brake serial numbers 101 thru 872. Beginning with S/N 873, 30-204A Brake Assemblies are assembled with P/N 065-15401 when new.

- 1) At the time of installation of MLG socket RAC P/N 129-810022-0003, or at next brake overhaul whichever occurs first, inspect aircraft records to determine if Main Wheel and Brake Assembly Conversion Kit P/Ns 199-184, 199-220, or 199-220A are installed.
- 2) Aircraft that have been identified as not being equipped with Conversion Kit P/Ns 199-184, 199-220, or 199-220A may be returned to service.
- 3) For aircraft that are identified as being equipped with the 199-184, 199-220, or 199-220A Wheel and Brake Kit, inspect the Brake Assembly to determine which torque ring part number is installed (ref. Figure 1).

- 4) If inspection indicates that the 065-15400 torque ring is installed, contact Parker Hannifin, Aircraft Wheel & Brake Division Service Center (Ph. 1-440-937-1272) for instructions to obtain replacement 065-15401 torque rings.
- 5) Consult CM 30-204A for disassembly and assembly instructions as required. Re-assemble with P/N 065-15401 in lieu of 065-15400. Note that P/N 065-15401 is marked to indicate that the assembly has been reworked in accordance with (IAW) Service Bulletin SB7079.
- 6) Aircraft with 30-204A main brake assemblies, reworked to use Parker P/N 065-15401 torque rings, may be returned to service.
