Wheels & Brakes

SERVICE BULLETIN

UPGRADE OF 40-77B NOSE WHEEL ASSEMBLY TO 40-77G CONFIGURATION

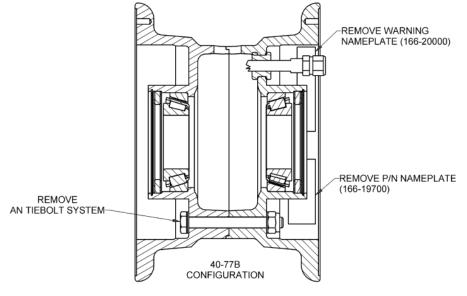
Figure 2

- Visually inspect to determine flange configuration per Figure 1. Proceed ONLY if the product has the Style "A" flange configuration. Note: Wheels that have Style "B" flange configuration ARE NOT eligible for upgrade, a newly manufactured 40-77G Wheel Assembly is required.
- 2) For new wheels that have not been mounted with tire, proceed to step 3. Jack aircraft, DEFLATE TIRE by threading a valve core depressing tool into the valve stem. Assure all air is removed from tire and remove valve core. Remove wheel IAW The New Piper Aircraft maintenance procedures. Disassemble wheel only after deflating tire and thoroughly inspect the wheel halves and components (except as noted in Table 2) for airworthiness IAW Parker AWBCMM0006 Component Maintenance Manual.
- 3) Disassemble wheel, remove and discard the wheel tie bolt hardware and nameplates listed in Table 2, below and as shown in Figure 2.
